MOUNT HOREB AREA SCHOOL DISTRICT

District Wide Facilities Study

March 31, 2016

Bray Associates Architects, Inc.

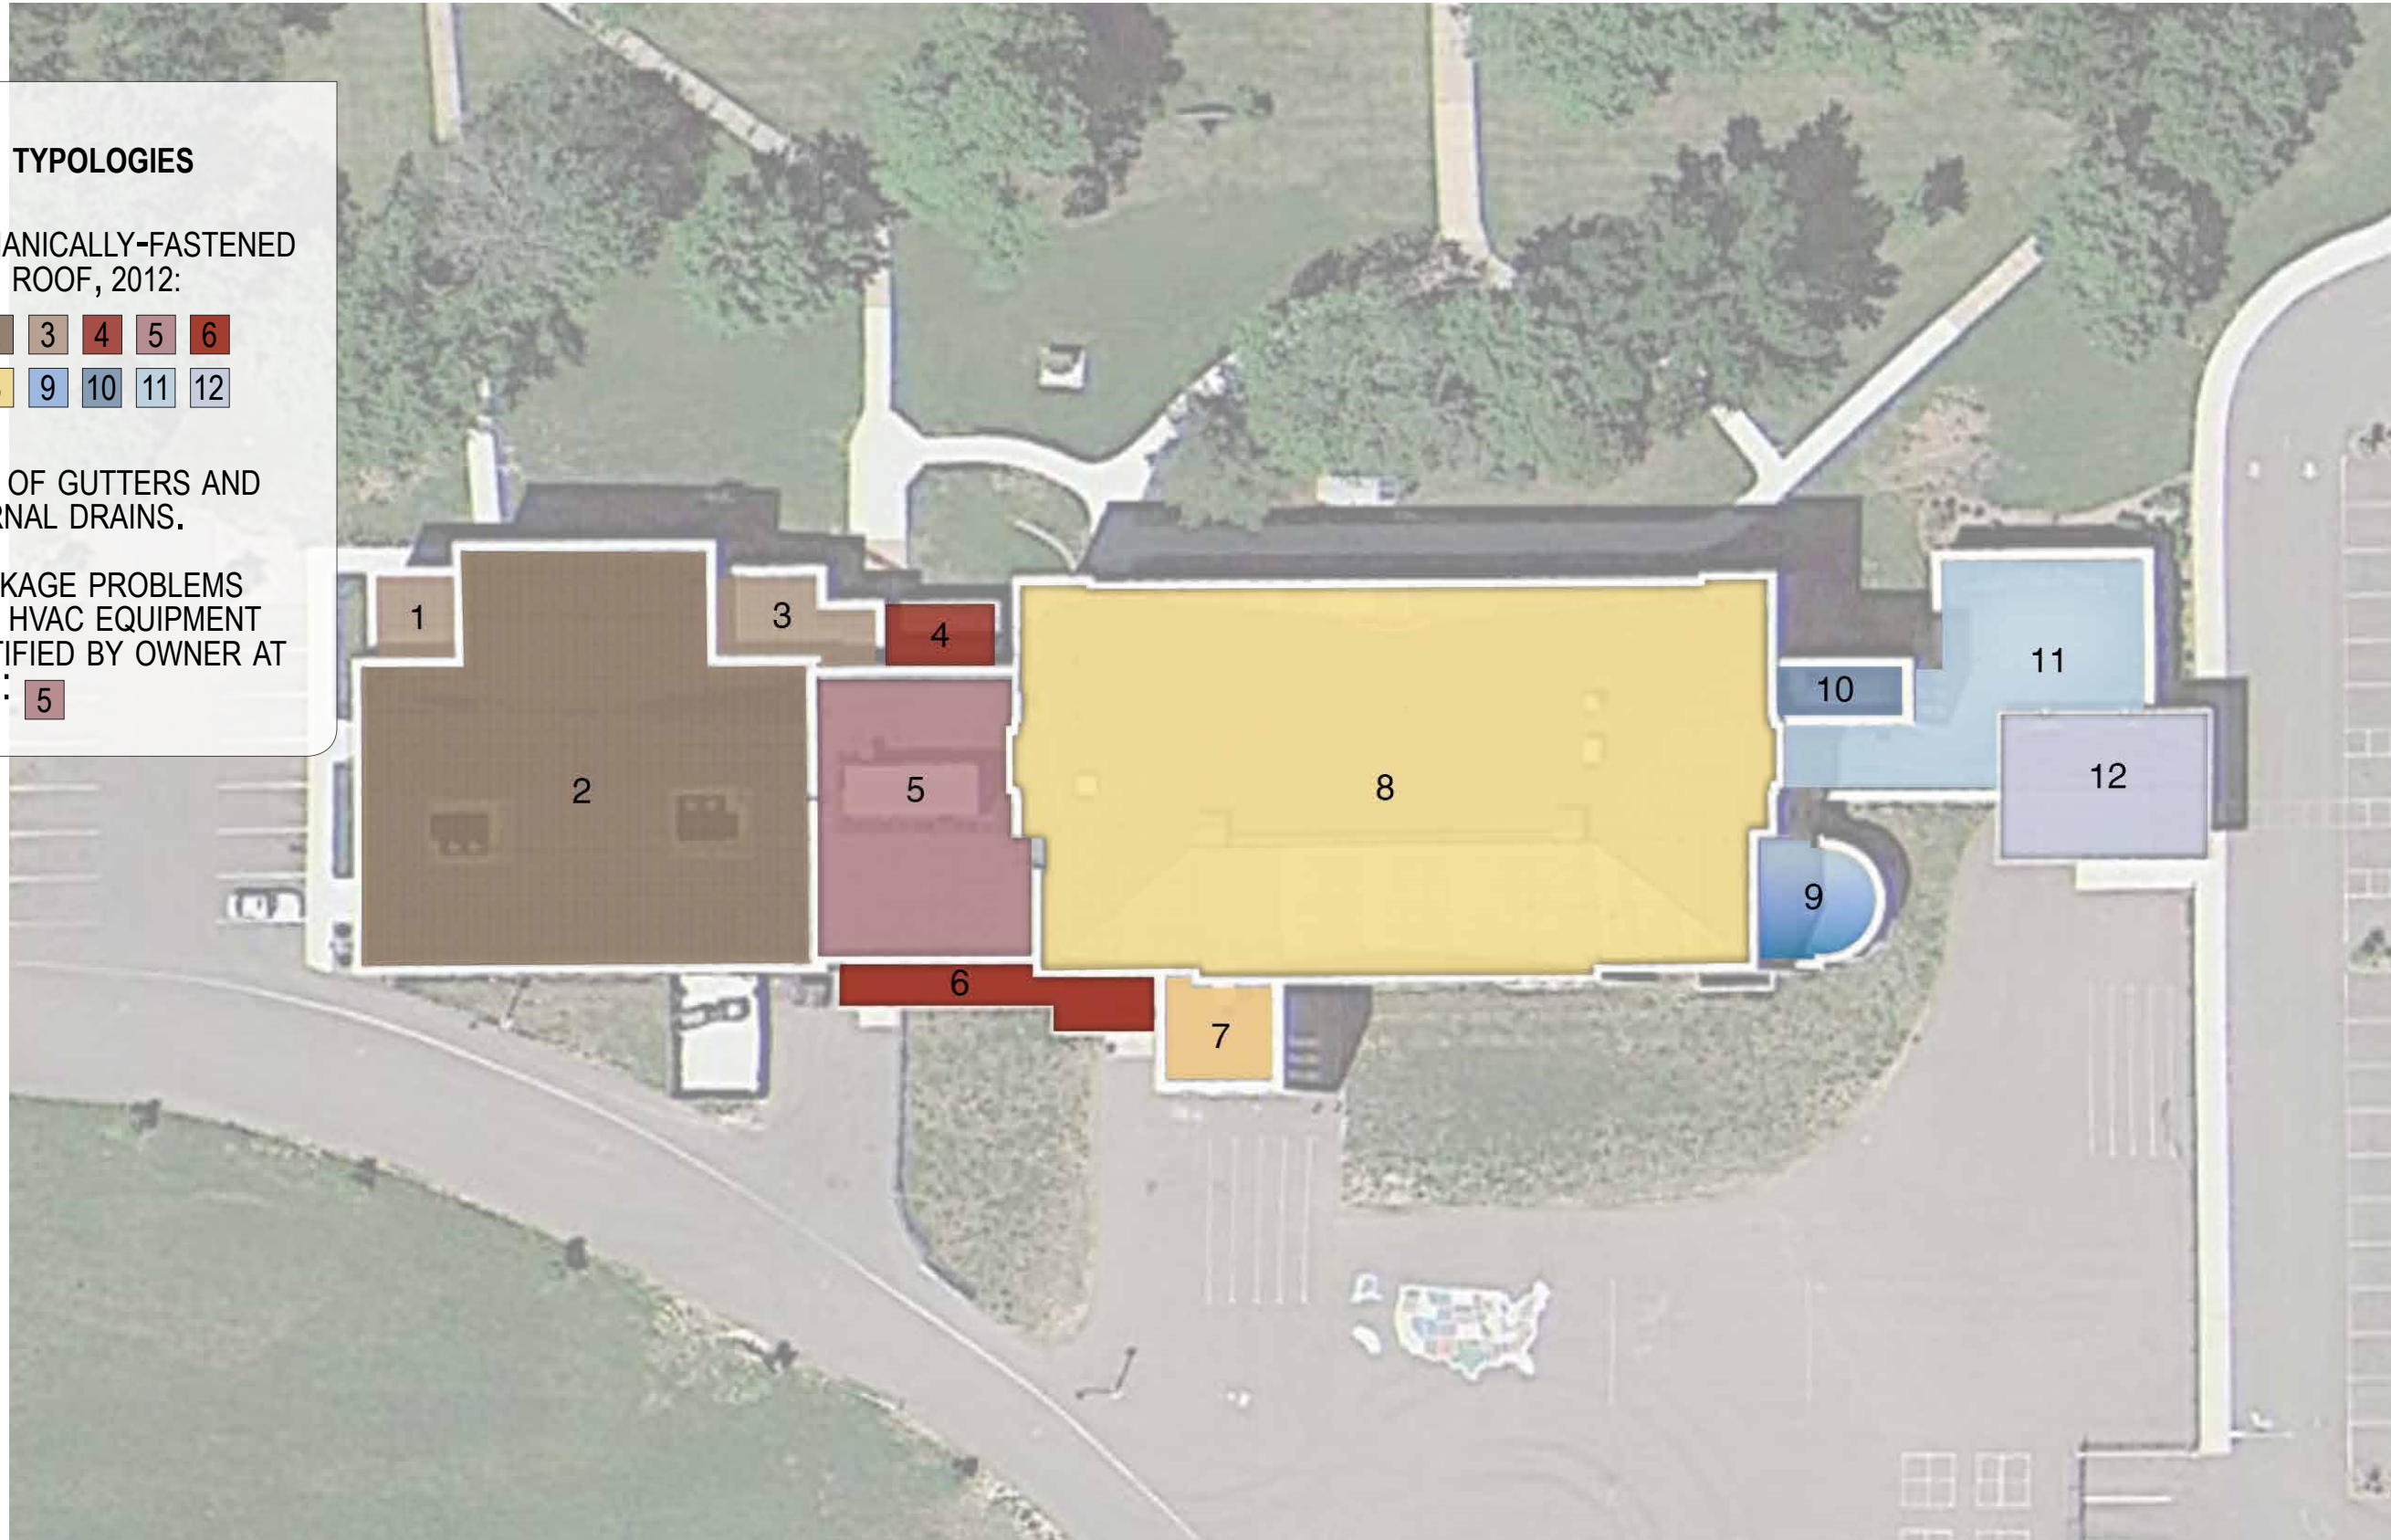
ROOF PLAN
not to scale

* LEAKAGE PROBLEMS
NEAR HVAC EQUIPMENT
IDENTIFIED BY OWNER AT
ROOF: 5

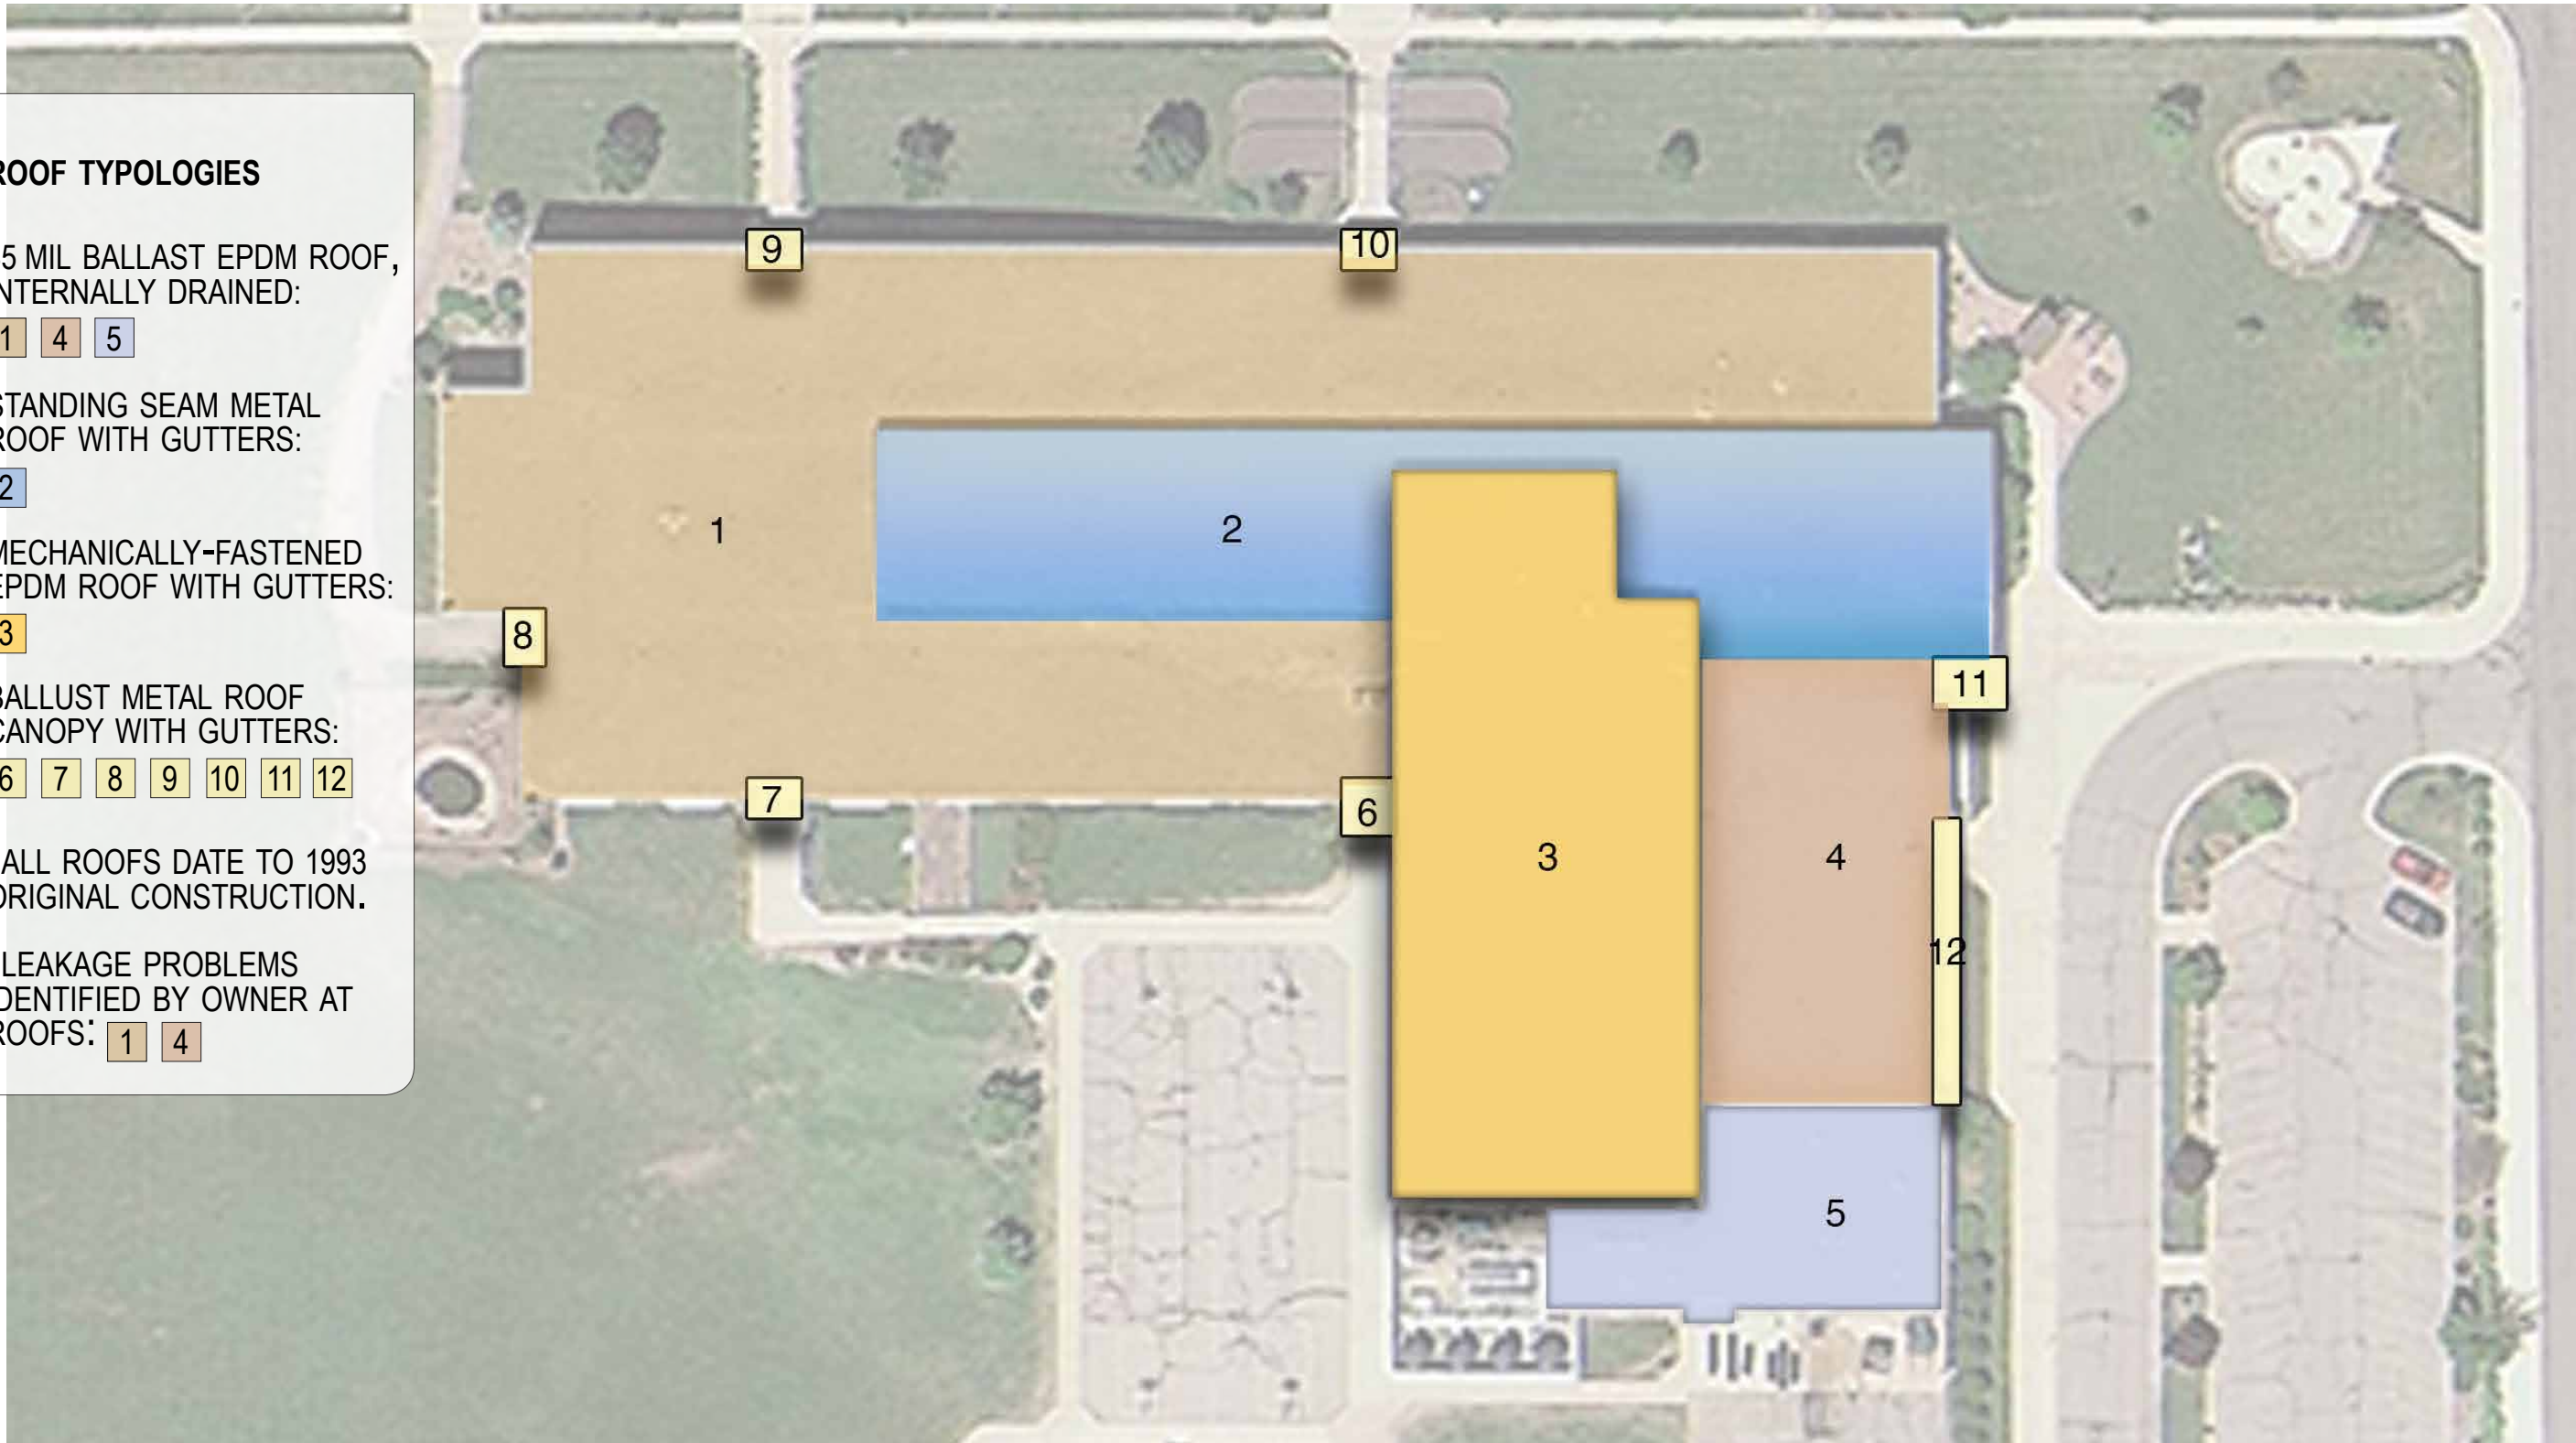
ROOF PLAN
 not to scale

*LEAKAGE PROBLEMS IDENTIFIED BY OWNER AT ROOFS: 1 4

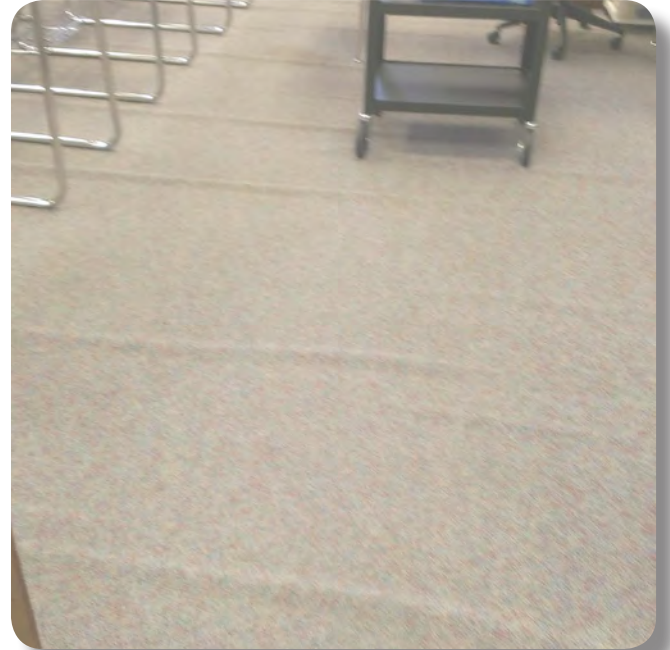
Mount Horeb Middle School Carpet Conditions

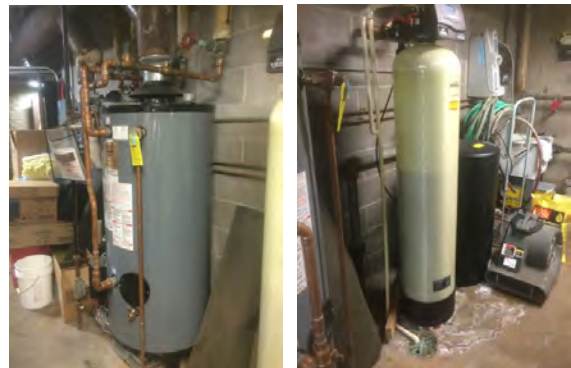
- A. The existing water heater is a gas-fired, atmospheric vented style water heater. The heater is relatively new and in good condition.
- B. The water heater appears to be sized appropriately for the building; however, the water heater is fairly inefficient.
- C. The water softener has recently been replaced and is in good condition.

- A. All equipment is in good condition. Should the water heater be replaced, the unit should be replaced with a sealed-combustion energy efficient model.

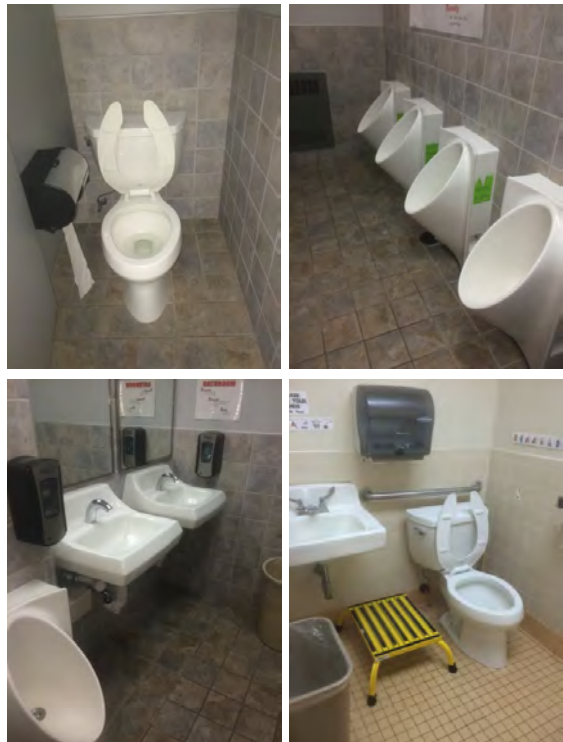
- A. Toilet rooms in the lower level have been recently remodeled and are in good condition.
- B. Toilet rooms located on the first floor have also been recently renovated and are in good condition.
- C. The toilet rooms located in the gym area are original to that building and are generally in poor condition.
- D. Electric water cools are in poor condition.
- E. Classroom sinks are in poor condition.
- F. Although toilet rooms have been remodeled, all rooms are not ADA compliant. Further investigation is required.
- G. Water less urinals are located on the first floor. Tank type water closet and wall hung lavatories are located within the new addition.

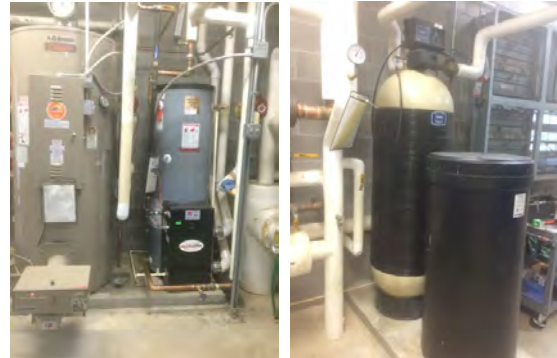
- A. The building has two domestic water heaters located in the mechanical room. A gas-fired, sealed combustion water heater has been provided for the main domestic hot water for the building. The water heater appears to be appropriately sized and in good condition.
- B. The water heater for the kitchen is a gravity vented water heater. The water appears to be oversized for the actual Kitchen demand. This style of heater is also rather inefficient.
- C. A small in-line booster pump has been provided for the irrigation system. The Owner indicated that this system is rarely ever used.
- D. The water softener is in good condition and appears to be sized appropriately for the building.

- A. Remove the existing water heater for the kitchen and installed a new sealed combustion water heater to be manifolded together with the domestic water heater for the building. This would allow the system to be more energy efficient. The water heaters would be set at 140 degrees with a mixing valve set at 120 degrees for the domestic water load.

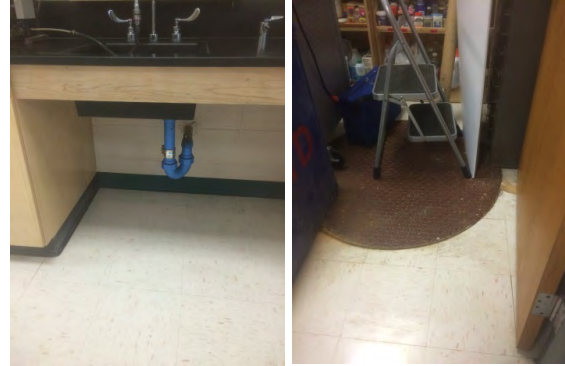
- D. Art room sinks have been provided plaster traps. The plaster traps are old and appear to be in fair condition.
- E. The original Science rooms have acid waste piping; however, they do not have an acid neutralization basin.
- F. The new Science rooms have acid waste piping and an acid neutralization basin. The acid basin has not been regularly maintained.

- A. Install a grease interceptor at the dishwasher to comply with current codes.
- B. Install individual acid basins at a few of the old science rooms. It would be extremely difficult to re-pipe the sewers to a new below ground unit.
- C. Provide continual maintenance on the existing plaster traps.

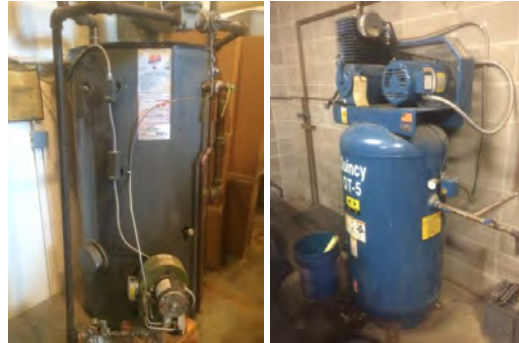
- B. The existing water softener has recently had the head unit replaced. The tank of the unit appears to be original.
- C. A small in-line booster pump has been provided for the irrigation system. The owner indicated that this system is rarely ever used.
- D. The water softener is in good condition and appears to be sized appropriately for the building.
- E. The air compressor for the Technical Ed rooms is in good condition and appears to be appropriately sized.
- F. Welding booths have been provided with portable equipment.

- A. Schedule the water heater for replacement. Provide new gas-fire sealed combustion, modulating styled heaters. Verify size of new heaters.
- B. Schedule water softener for replacement. Soften hot and cold water and verify size of softener.
- C. Continually maintain air compressor.

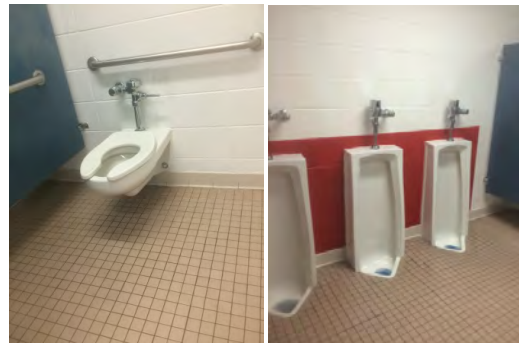
- A. Portions of this building have the original plumbing fixtures located in the toilet rooms, while other toilet rooms have been renovated. Original plumbing fixtures are in poor condition. Fixtures that have been replaced are in very good condition and appear to be water efficient.
- B. Original Science rooms are in poor condition. Emergency gas shut-off is inadequate. Faucets have cold water only.
- C. New Science rooms are in good condition. Sinks have hot and cold water, emergency gas shut-off is adequate and the rooms have an emergency eye wash and shower.
- D. Art room sinks are in fair condition.
- E. Home Economics/FACE room sinks are in poor condition.

- A. Original plumbing fixtures should be scheduled for replacement.
- B. Install hot and cold water at all science room sinks. Provide new gas shut-off controls for the Science rooms.
- C. Schedule Art rooms sinks and plaster traps for replacement.
- D. Schedule FACE rooms sinks for replacement.

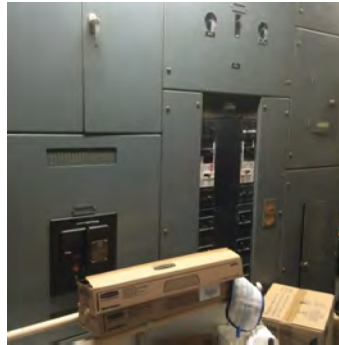
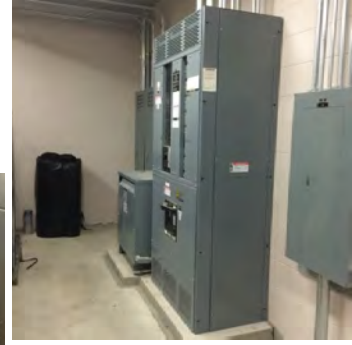
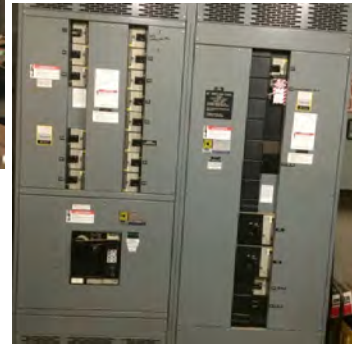
- A. The facility is fed with two separate electrical services: the first is a 277/480 volt 3 phase 4 wire electrical service, 1200 amps. This service is fed with a utility pad mounted transformer; the second service is a 277/480 volt 3 phase 4 wire electrical service, 1200amps. This service is fed with a utility pad mounted transformer.
- B. The main service switchboard does have a Liebert surge protection device.
- C. The existing service panels have space for additional breakers.
- D. The football field is fed with a separate electric service.
- E. The existing 1962 service is still in place and backed from the service installed in 1996.

- A. Both services are in good condition. Small additional loads can be added to both services if required. If large loads are planned, a new service may be required.
- B. Replace the existing 1962 distribution with new I-line type gear and new breakers.

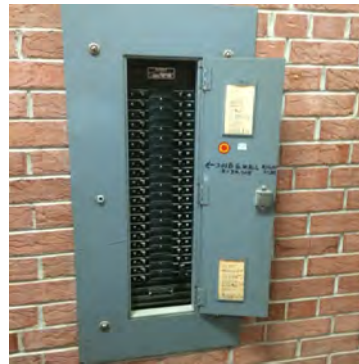
- A. A majority of the panels in the facility are old style Kinney type dated to the original construction of the facility.
- B. There are approximately 25 old style panels.
- C. Newer sections of the facility have panels in good to fair condition and do not need replacement.
- D. Staff indicated a lot of problems with breakers tripping in science labs. These are panels noted above as old style

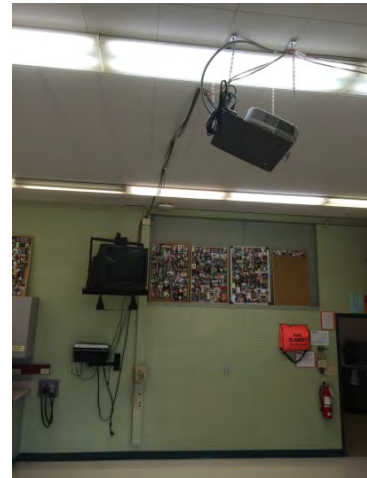
- A. No master shut off for shop equipment was noted.
- B. Mag starters were not present on all shop equipment to prevent re-start in the event of loss of power.
- C. We noted a lot of surface cabling in classrooms.
