MOUNT HOREB AREA SCHOOL DISTRICT

District Wide Facilities Study

March 31, 2016

Bray Associates Architects, Inc.

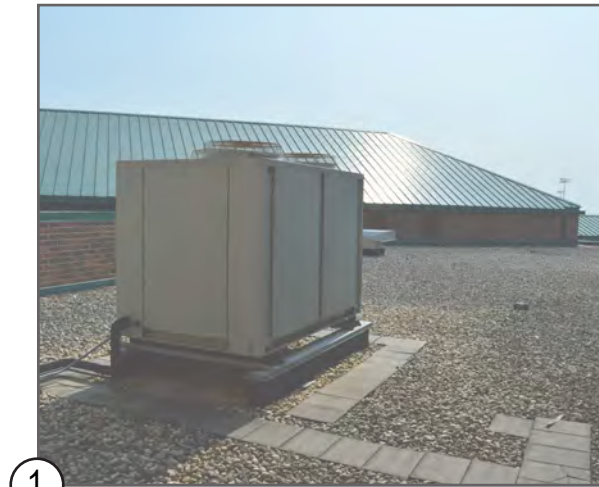
① ROOFTOP MECHANICAL UNIT

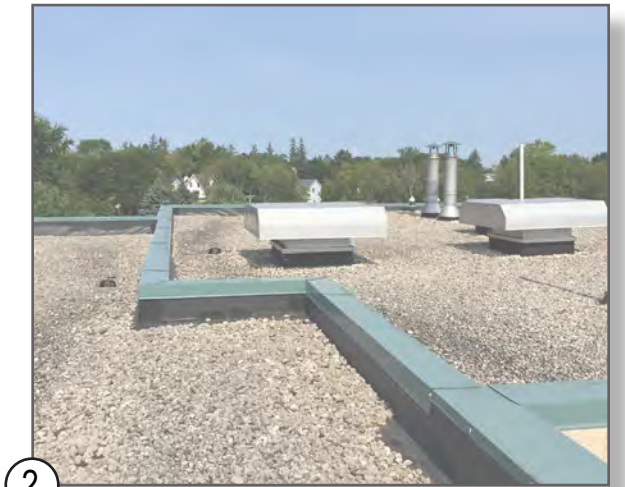
② ROOFTOP VENTS

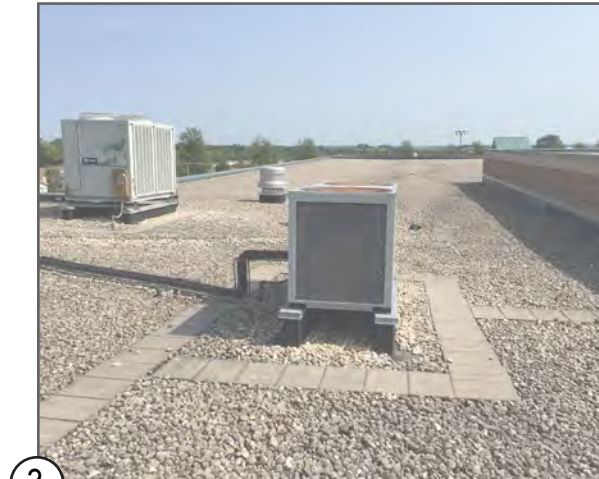
③ ROOFTOP MECHANICAL UNIT

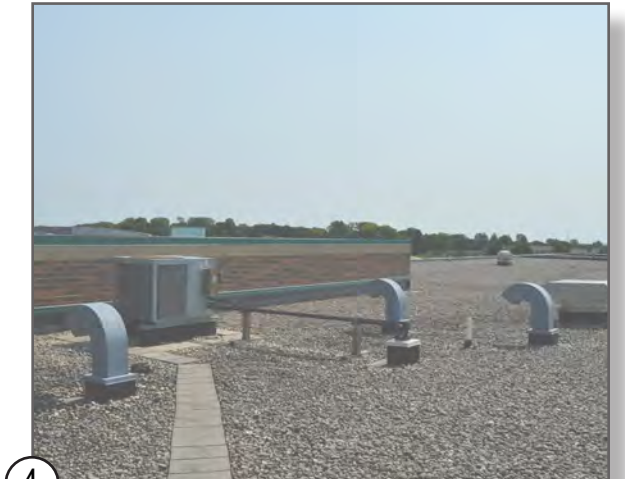
④ ROOFTOP MECHANICAL UNIT & VENTS

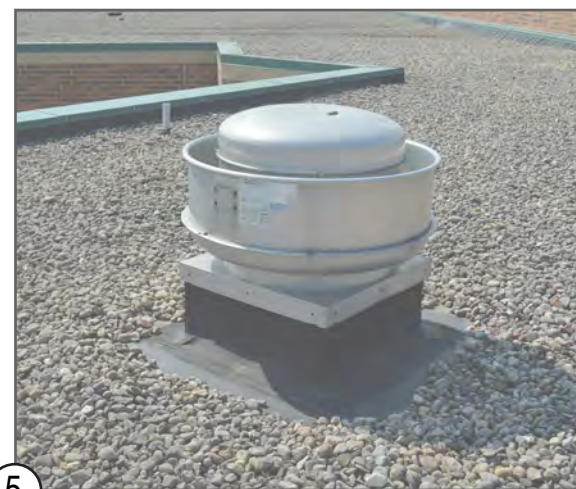
⑤ ROOFTOP FAN

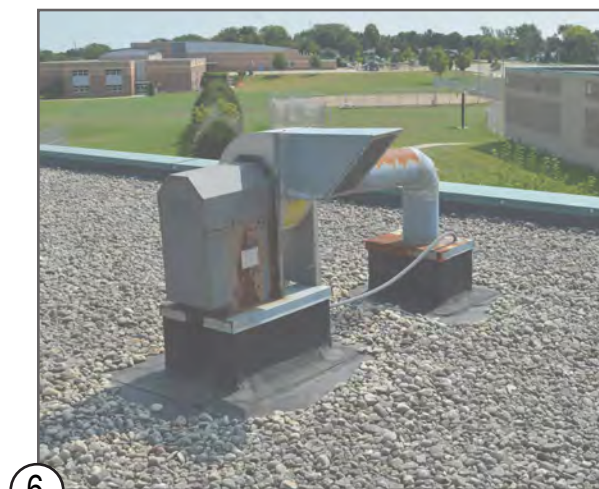
⑥ ROOFTOP MECHANICAL EQUIPMENT

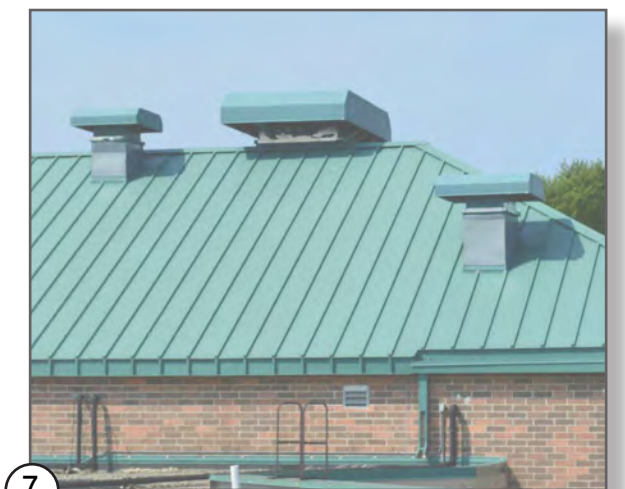
⑦ ROOFTOP VENTS

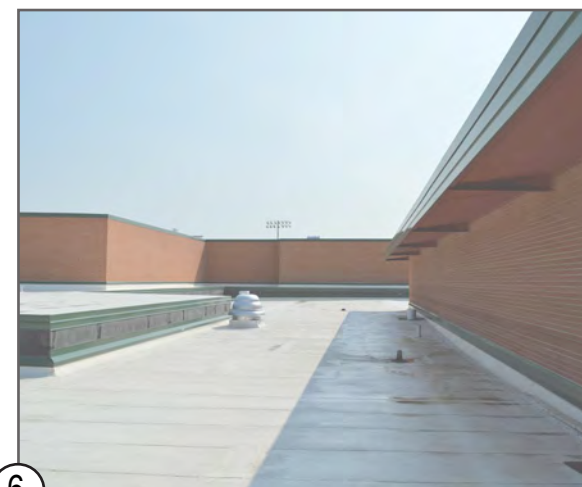
6 ROOF SOFFIT AND MULTIPLE ROOF TRANSITIONS
