MOUNT HOREB AREA SCHOOL DISTRICT

District Wide Facilities Study

March 31, 2016

Bray Associates Architects, Inc.

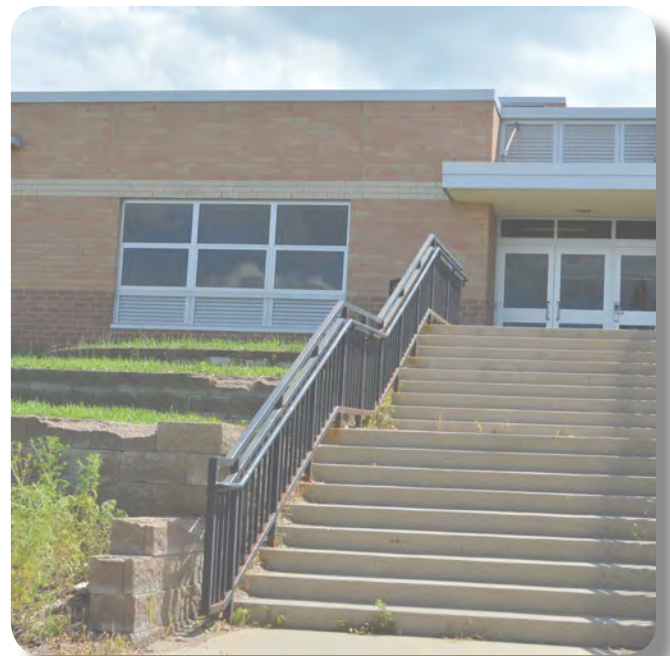
Mount Horeb Intermediate Center Steps

- HVAC
 - Inconsistent air temperature
- Electrical Upgrades
 - Lighting within classroom is difficult to control and compromises visibility of SMART board
 - Electrical problems noted by owner in classrooms south of the library
 - Wireless internet/technology upgrades; SMART boards outdated
- Carpeting buckling and showing wear at seams
- New/more colorful paint desired throughout to improve wayfinding; potential for murals, school logo or mission statement
- Some exterior doors fail to close; replacement needed
- Exterior concrete steps failing

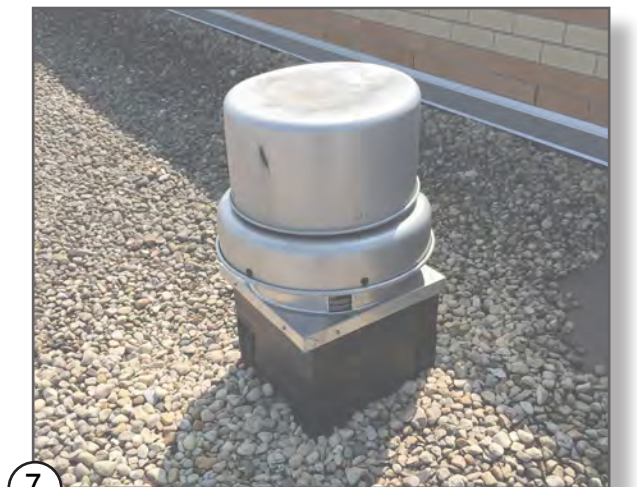
7 ROOFTOP MECHANICAL FAN

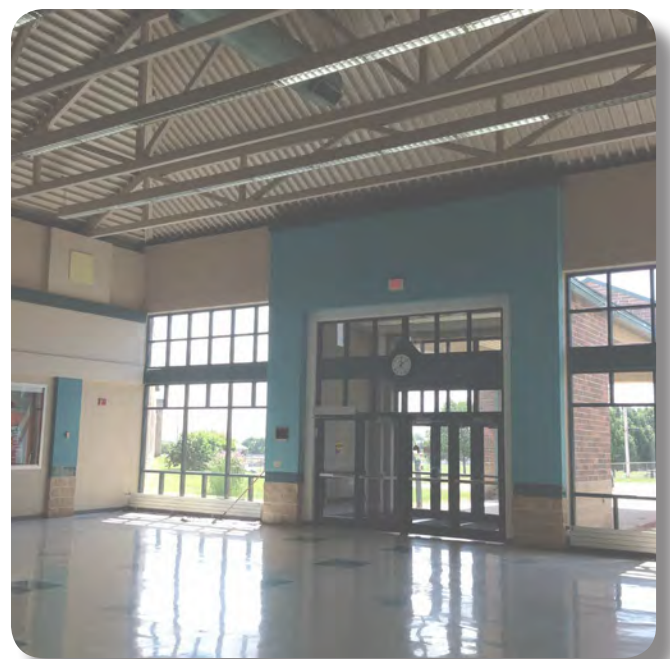
Mount Horeb Middle School Main Entry

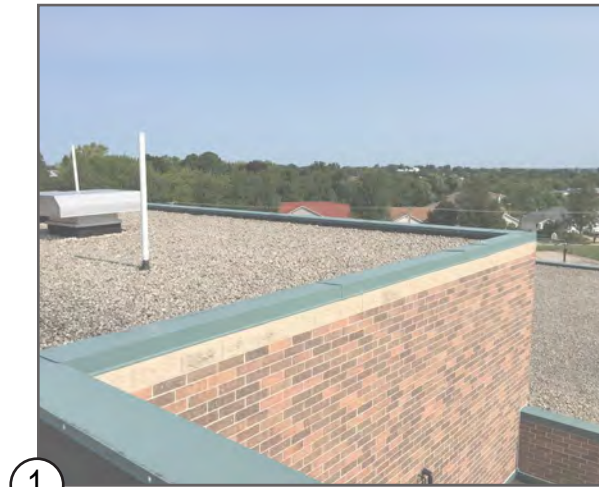
1 METAL COPING

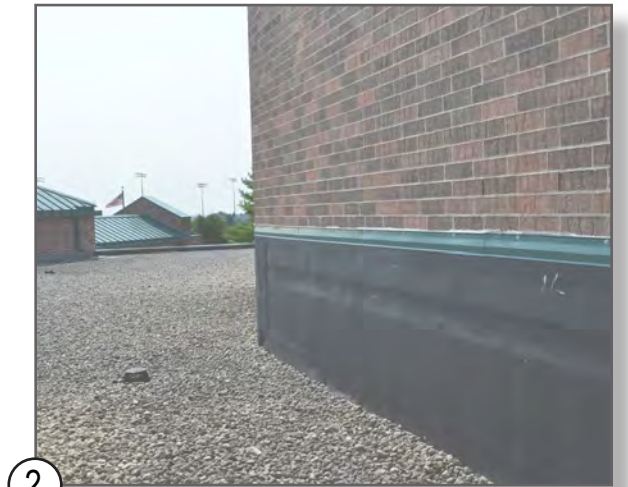
2 ROOF TO WALL CONNECTION

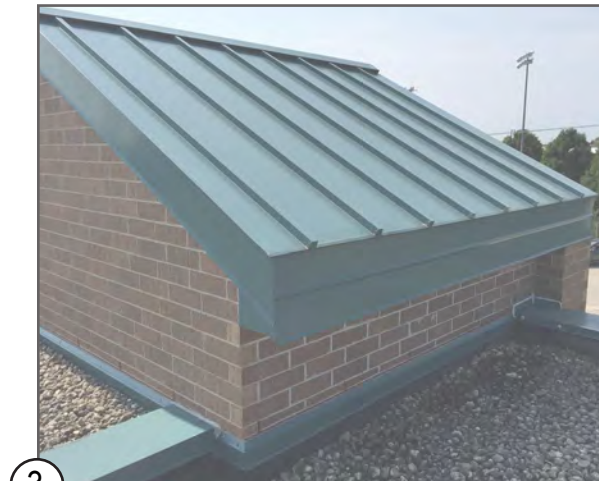
3 STANDING SEAM ROOF WITH SHEET DRAIN

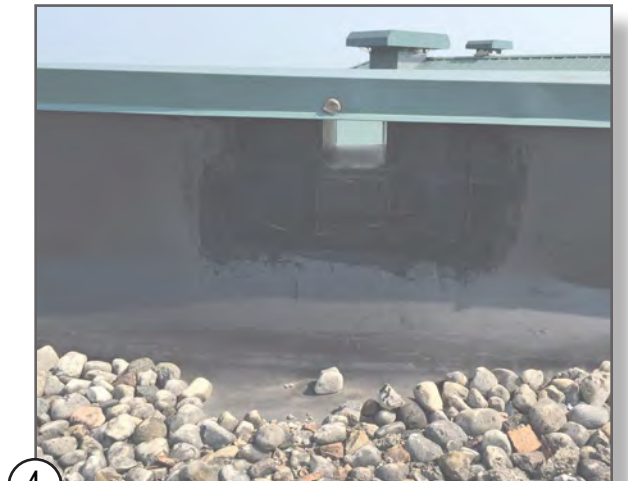
4 ROOF SCUPPER

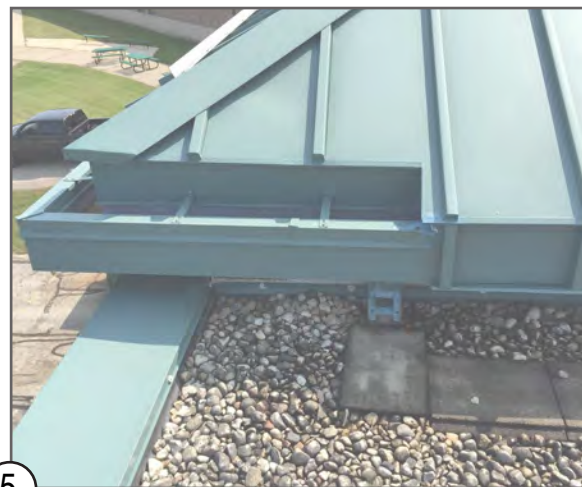
5 METAL GUTTER & SHEET DRAIN

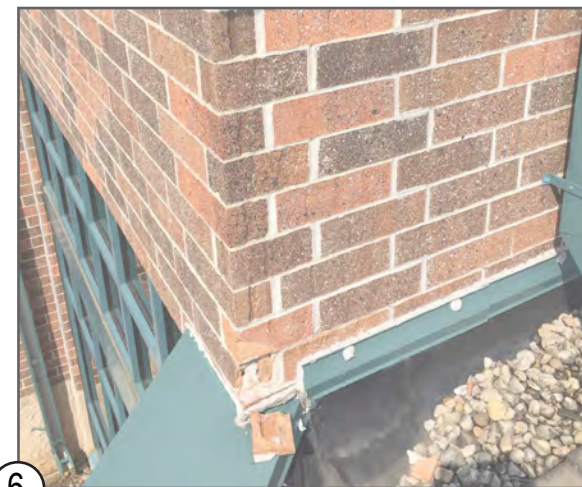
6 ROOF TO WALL CORNER CONNECTION

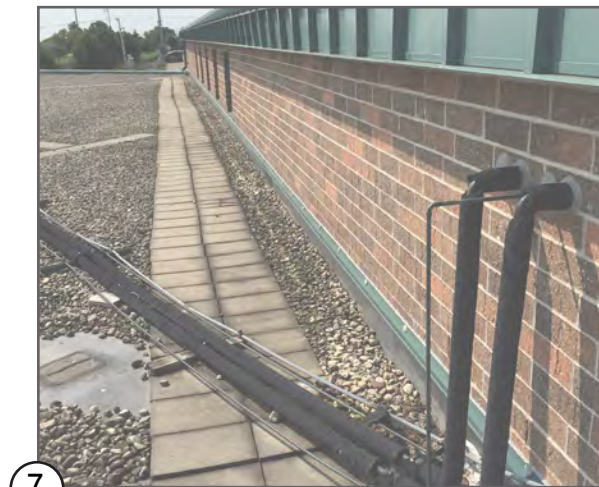
7 ROOF TO WALL CONNECTION

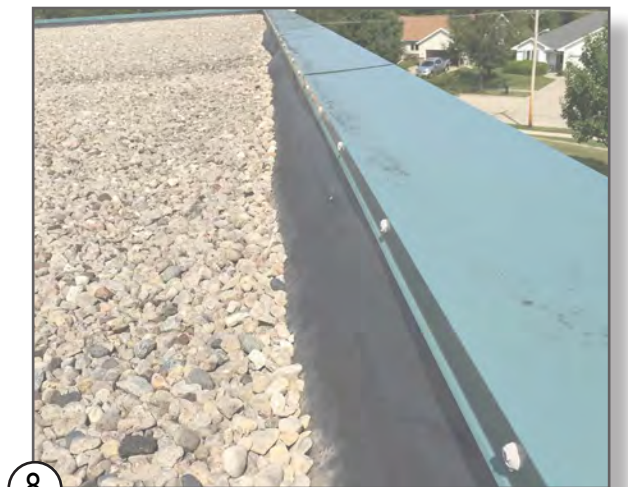
8 METAL COPING

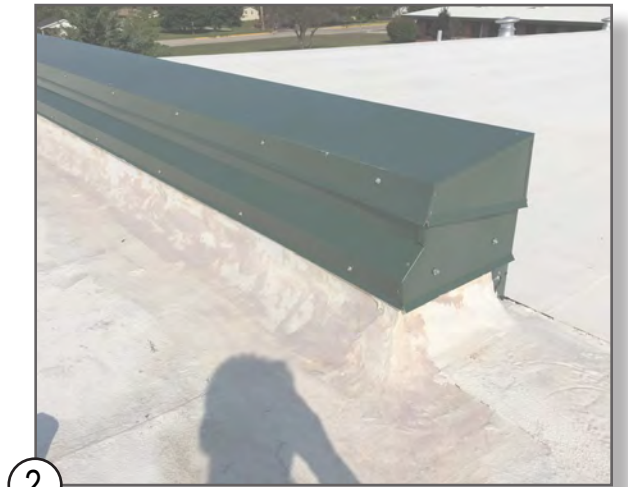
2 ROOF PARAPET WITH METAL COPING

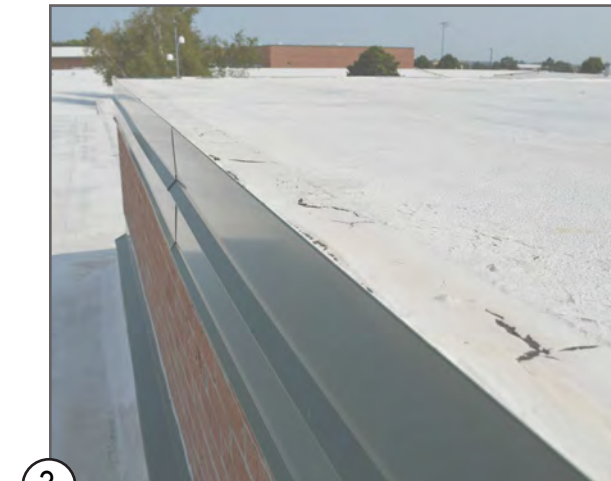
3 ROOF EDGE WITH METAL ROOF EDGE MATERIAL

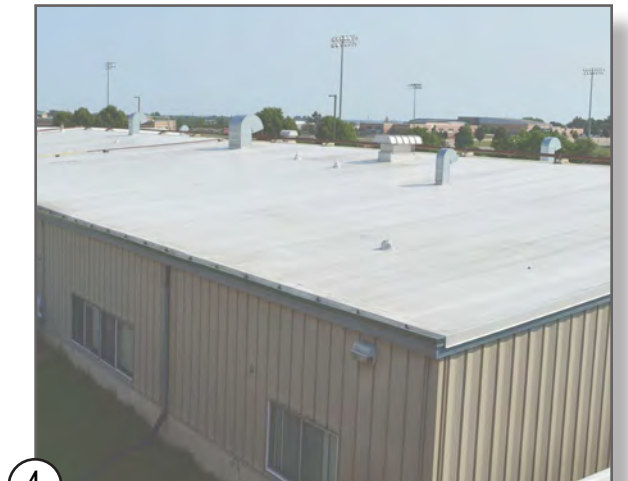
4 METAL ROOF EDGE

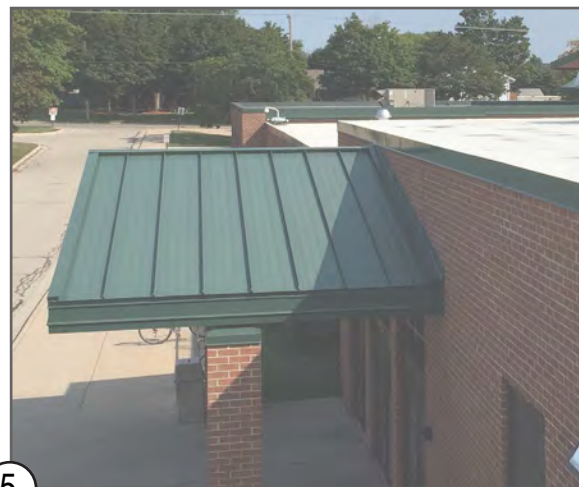
5 CANOPY ROOF AND WALL CONNECTION

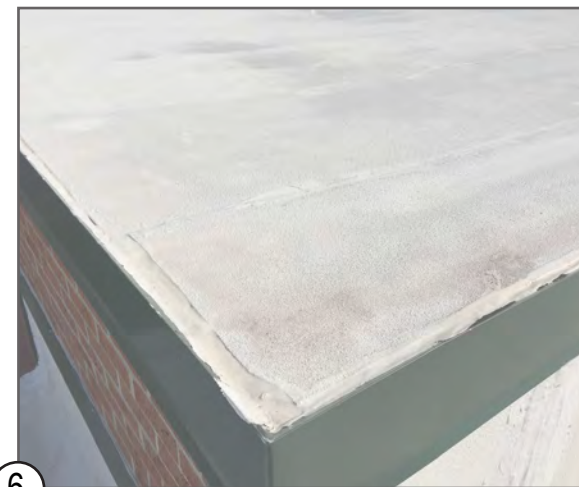
6 CORNER EDGE CONDITION

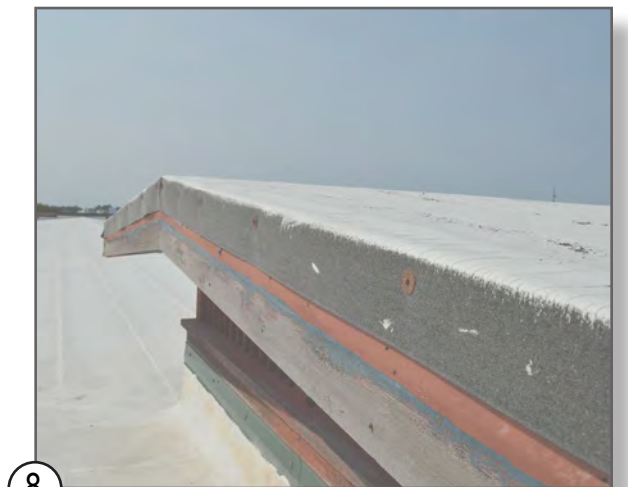
8 EXPOSED BACKING FASCIA

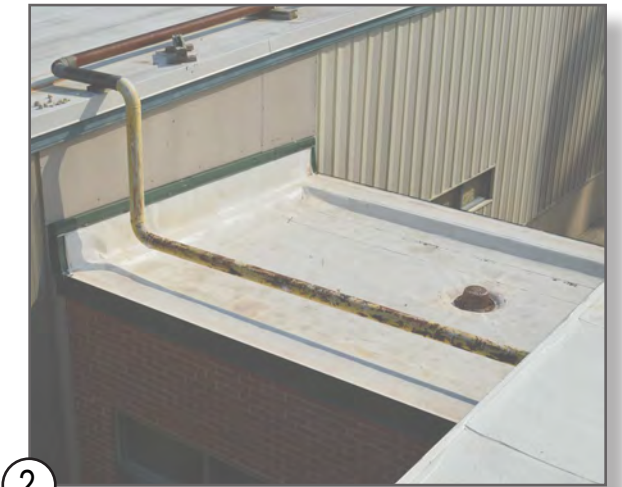
2 ROOF TO WALL CONNECTION AT CORRIDOR

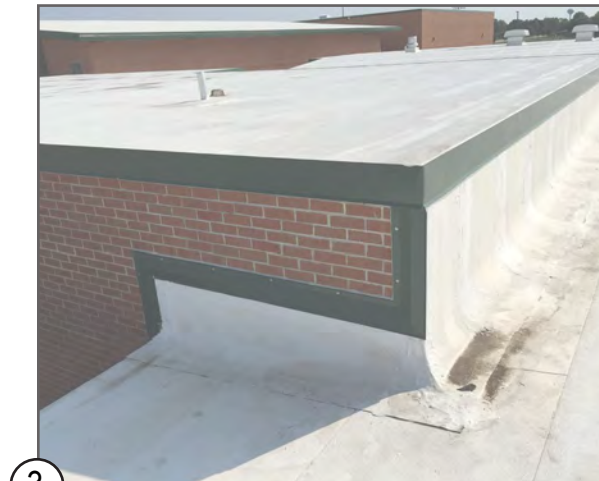
3 ROOF TO WALL CORNER CONNECTION

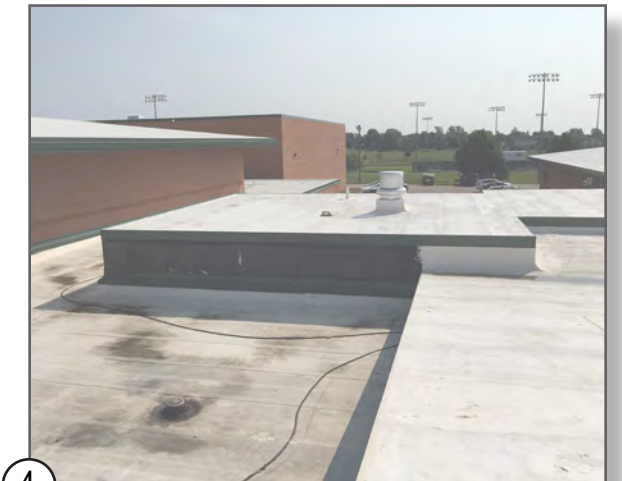
4 MULTIPLE ROOF TRANSITIONS

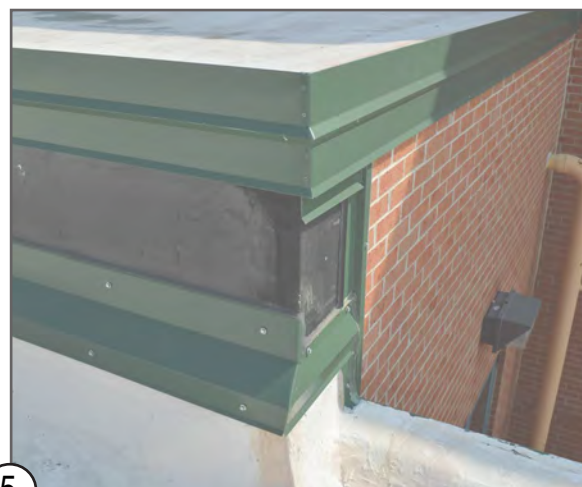
5 ROOF TO WALL CORNER CONNECTION

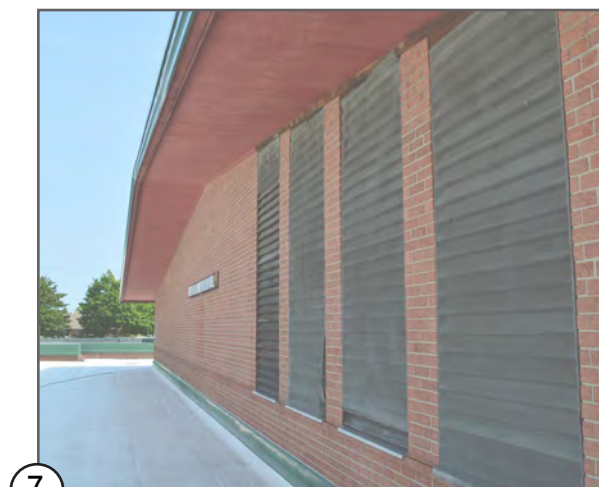
7 SOFFIT CONDITION

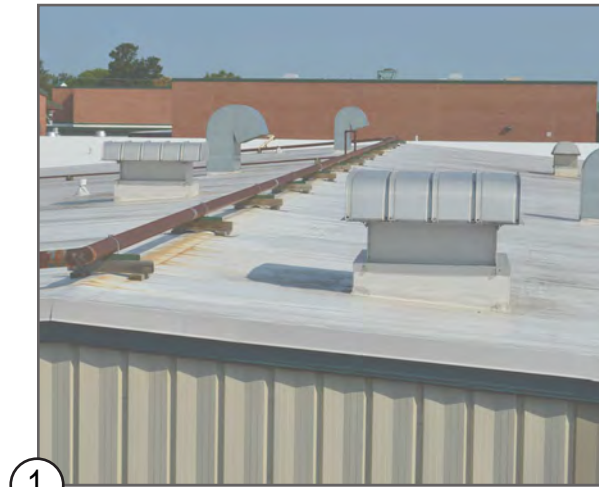
1 ROOFTOP VENTS

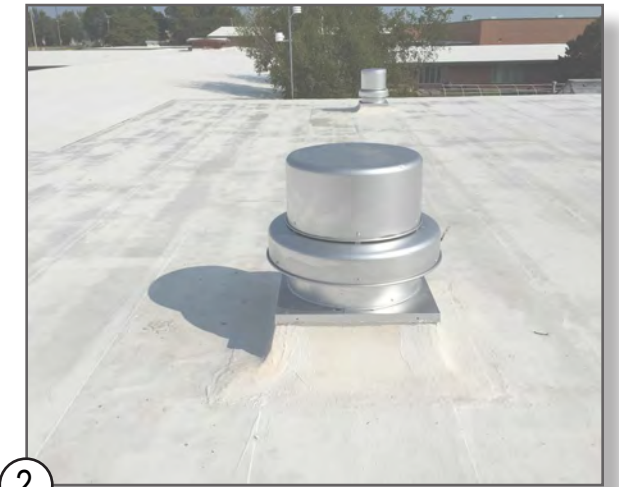
2 ROOFTOP FAN

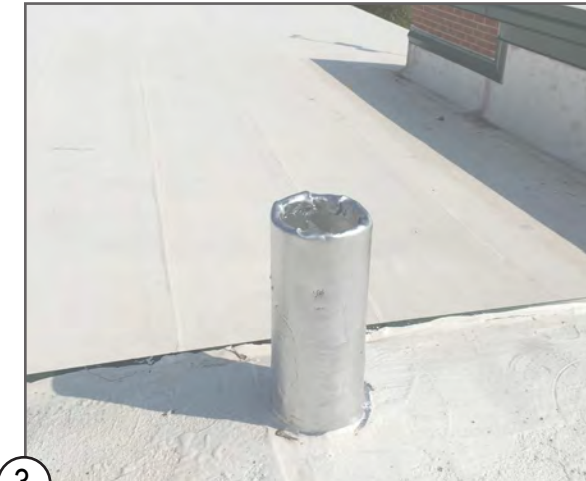
3 ROOFTOP VENT

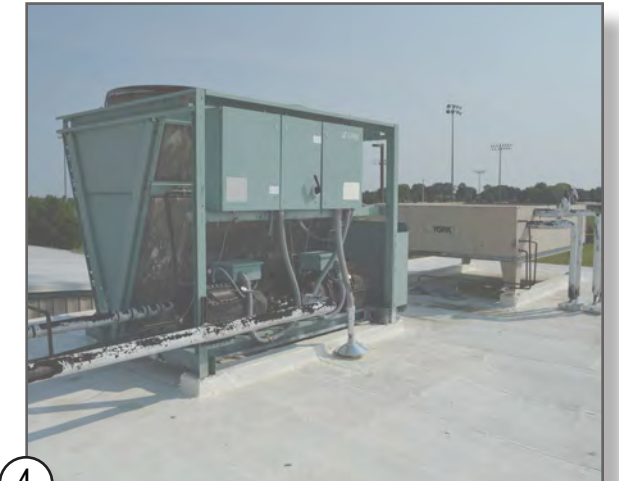
4 ROOFTOP MECHANICAL UNIT

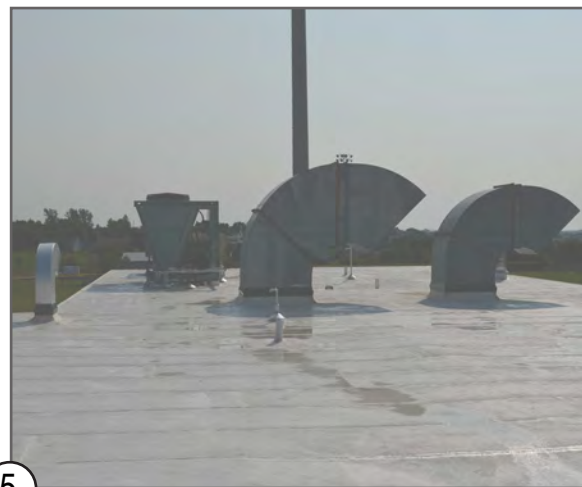
5 ROOFTOP VENTS

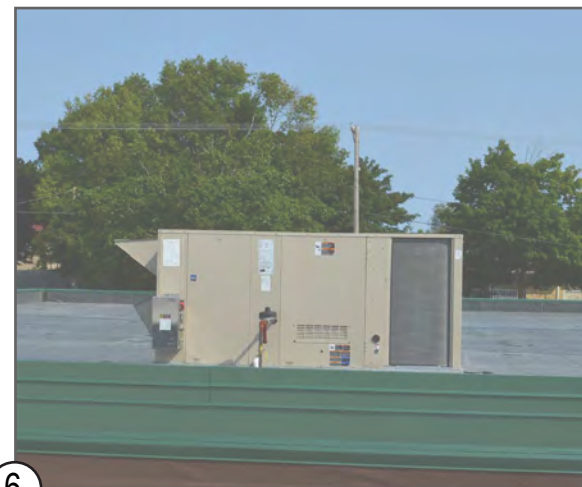
6 ROOFTOP MECHANICAL UNIT

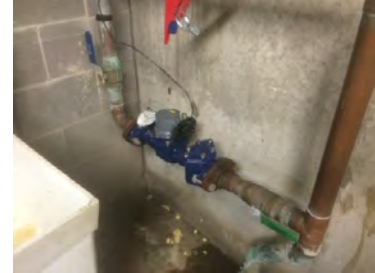
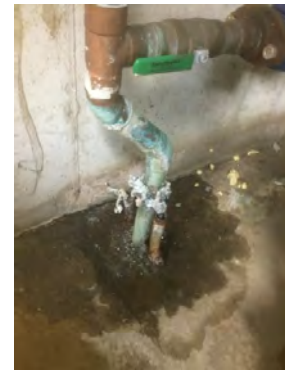
- A. The building is supplied by a 2" water service and 2" water meter. The majority of the water piping appears to be type "L" copper tube. The piping appears to be in fair condition.
- B. Water pressure in the building appears to be good.
- C. All hot water and cold water to plumbing fixtures is softened.
- D. The water main into the building is grounded. There appears to be a lot of electrolysis forming on the pipe indicates that there is a problem with the ground. Further investigation is required.
- E. All water piping to the gymnasium is located in tunnels below the gym floor.

- A. Continually monitor water piping for leaks.
- B. Investigate grounding problem at the water service entrance to the building.

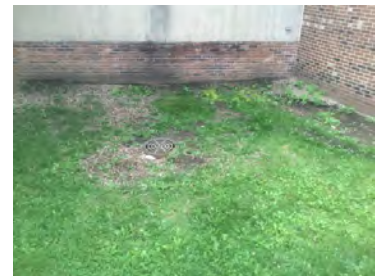
- A. The existing interior storm piping system appears to be operating well. The existing room above the classroom shed directly to grade.

- B. Exterior storm is in poor condition. Currently, storm water floods a portion of the site which then allows water to penetrate the building. This is also causing a major erosion problem along the outside of the building.

- A. The existing site requires new grading and new exterior storm piping to correct the existing condition. Further investigation is required.

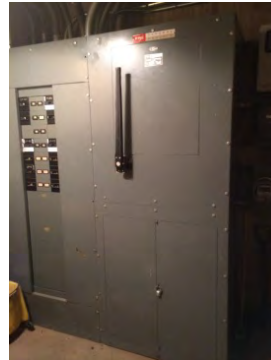
- A. The facility is fed with one 120/208 volt 3 phase 4 wire electrical service, 800 amps. The service is a very dated Federal Pacific type. The service is fed with a pad mounted transformer.
- B. The main service switchboard does have a surge protection device.
- C. The existing service panel is full and no additional space is available for additions.
- D. The meter is located in the building.
- E. A separate disconnect is used to feed emergency loads.
- F. Owner noted water leaks in this room during a heavy rain event as the service gear is located in a lower level HVAC equipment space.

- A. Due to the service age we would recommend full replacement.

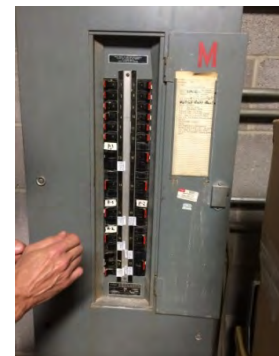
- A. A majority of the panels in the facility are old style and staff noted some breakers do not reset.

- A. Replace all old style panels with new in place. Existing feeders can remain.
- B. We noted approximately 10 old style panels in need of replacement.

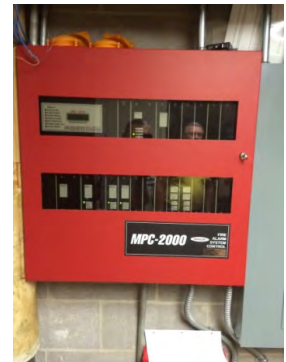
- A. A MPC-2000 zoned Fire alarm panel is installed
- B. It appears some of the devices have been updated in classrooms to new horn/strobes.
- C. Old style smoke detectors were noted in corridors.
- D. The fire alarm system is monitored by silent night. The owner noted this is not functioning.

- A. Due to the age of the system and non-addressable devices, we recommend full replacement. This would bring the facility up to full code compliance with the fire alarm system.

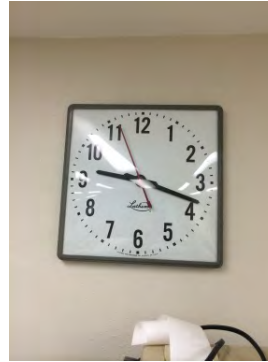
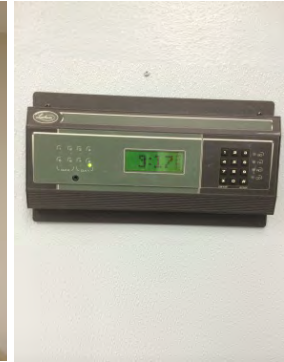
- A. An older style Latham clock system is installed.
- B. Staff noted the clock system fails frequently and does not sync properly.
- C. The main clock panel is located in the office area.

- A. If additional clocks need to be added or if an upgrade was considered, we would recommend a wireless clock solution such as primex or equal.

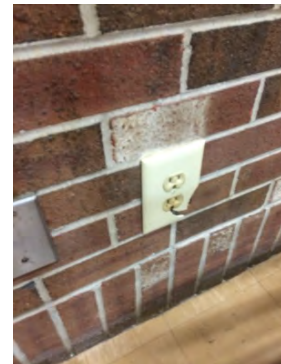
- A. We noted a lot of broken receptacles and electrical devices in need of upgrade.

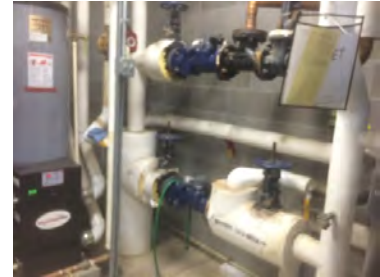
- A. The building is supplied by a 6" combination water service with a 3" water meter. Although the water service is large enough to accommodate fire protection for the entire building, the building does not have fire protection.
- B. Domestic water piping in the building is type "L" copper tube. This piping is in good condition.
- C. The building also has a 3" water sub-meter for an irrigation system. The owner indicated that the irrigation system is rarely used.
- D. Hot water is supplied to the Kitchen at 140 degrees.

- A. The water service is large enough to provide fire protection for the building. Investigate the option for fire protection.

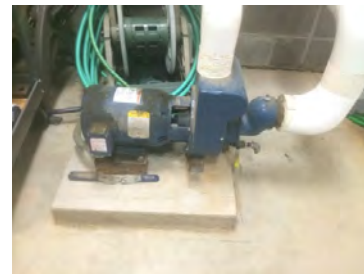
- A. The building has two domestic water heaters located in the mechanical room. A gas-fired, sealed combustion water heater has been provided for the main domestic hot water for the building. The water heater appears to be appropriately sized and in good condition.
- B. The water heater for the kitchen is a gravity vented water heater. The water appears to be oversized for the actual Kitchen demand. This style of heater is also rather inefficient.
- C. A small in-line booster pump has been provided for the irrigation system. The Owner indicated that this system is rarely ever used.
- D. The water softener is in good condition and appears to be sized appropriately for the building.

- A. Remove the existing water heater for the kitchen and installed a new sealed combustion water heater to be manifolded together with the domestic water heater for the building. This would allow the system to be more energy efficient. The water heaters would be set at 140 degrees with a mixing valve set at 120 degrees for the domestic water load.

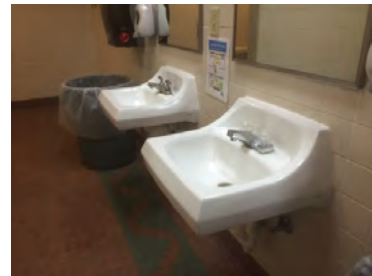
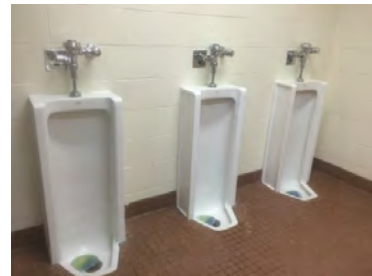
- A. Generally, plumbing fixture in this facility are in good condition and have been well maintained.
- B. Toilet rooms are generally in good condition. Water closets are wall hung, manually operated flush valves. Urinals are floor outlet with hard wired sensor flush valves and the lavatories are wall hung with manual faucets. The faucets on the lavatories are generally in poor condition.
- C. Classroom sinks are in stainless steel with gooseneck faucets and a bubbler attachment. The sinks are in fair condition.

- A. Provide continual maintenance on all plumbing fixtures
- B. Schedule the faucets on the lavatories for replacement.

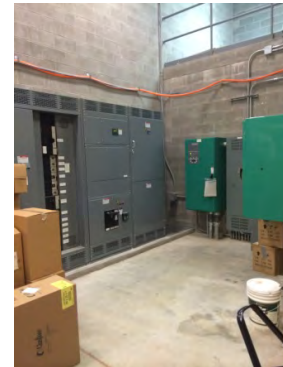
- A. The facility is fed with a 277/480 volt 3 phase 4 wire 2000 amp service. The service is fed with a pad mounted utility transformer located outside the electrical equipment room.
- B. The existing service panel has room for additional breakers and is sized to accommodate addition load.
- C. The meter is located outside the building next to the utility transformer.

- A. Add to service if required to accommodate additional load. If a large building addition is planned for this facility, the service will need to be evaluated.

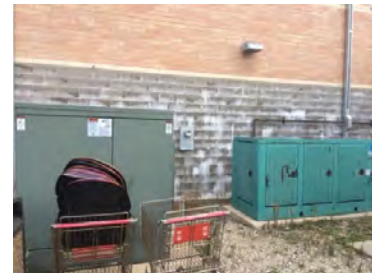
- A. The generator is a 67 Kw Onan type, natural gas fired and air cooled.
- B. The generator is located outside in a shared utility transformer enclosure and is locked.
- C. The emergency loads are split to comply with code. A life safety and non-life safety transfer switch is present.
- D. It would appear based on the loads observed in the generator panels that small loads can be added if required

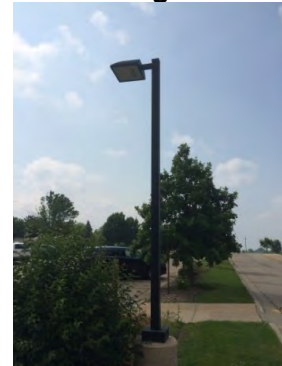
- A. The fixtures throughout are T8 type and in good condition.
- B. Exterior fixtures are HID type

- A. Consider replacing the exterior lighting with LED type.

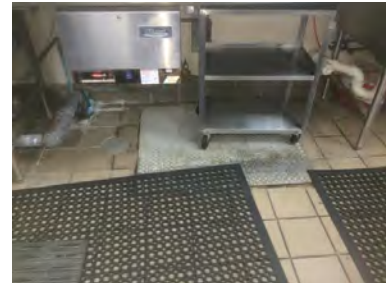
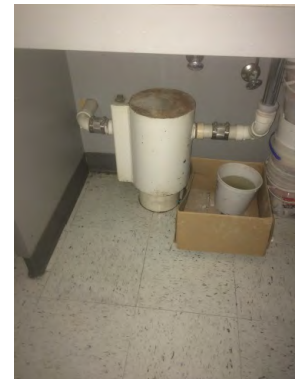
- A. Sanitary waste and vent, and storm piping materials are Schedule 40 PVC. Based on the age of the building, the piping systems are expected to be in good condition.
- B. An interior grease interceptor is located in the floor slab of the Kitchen. The grease interceptor appears to be adequately sized.
- C. An acid neutralization basin has been provided for the Science classrooms.
- D. All art room sinks have been provided with plaster traps.
- E. Roof drainage and storm drainage was reported to be in good condition.

- A. Provide continual maintenance for the grease interceptor, acid basin, and plaster traps.

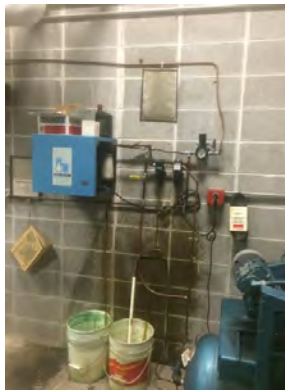
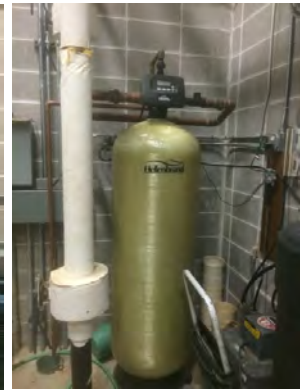
- A. The domestic hot water heating system consists of two (2) gas-fired, sealed combustion water heaters and a storage tank approximately 200 gallons in capacity.
- B. The water heating system is over-sized for the actually hot water load in the building.
- C. Water heating equipment is nearing the end of its life expectancy.
- D. The water softener is in good condition.

- A. Schedule the existing water heating equipment for replacement. The equipment should be resized for the actual building demand. Instal new gas-fired, sealed combustion modulating water heaters.

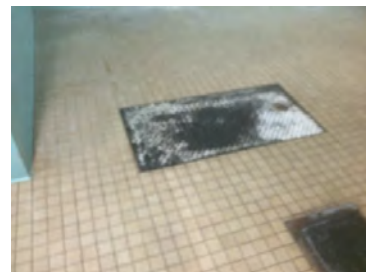
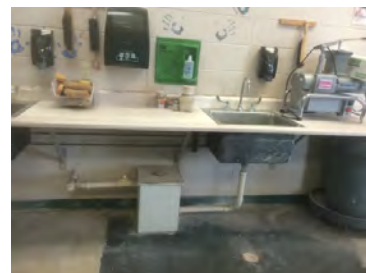
- A. The building is a gravity drained system which discharges to the street. Original sewers are cast iron pipe with galvanized vent piping. Based on the age of the building, it is expected that these sewers are in fair condition.
- B. New additions have been provided with schedule 40 PVC piping. Based on the age of the piping it is expected to be in good condition. Based on the age of the additions it is expected that the piping is in good condition.
- C. An interior grease interceptor is located in the Kitchen; however, the 3-compartment sink which it served has been removed. Should the kitchen be renovated, a new grease interceptor would be required for the dishwasher and potentially other devices.

- D. Art room sinks have been provided plaster traps. The plaster traps are old and appear to be in fair condition.
- E. The original Science rooms have acid waste piping; however, they do not have an acid neutralization basin.
- F. The new Science rooms have acid waste piping and an acid neutralization basin. The acid basin has not been regularly maintained.

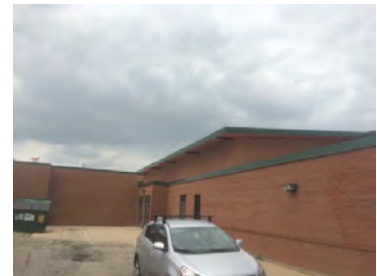
- A. Storm piping is a combination of gravity drained roof drains with internal piping, pitched roofs with gutters and downspouts and pitched roofs that shed directly to grade. The owner indicated there were problems with the existing underground storm drainage system.
- B. Water which is shedding directing from the roof to grade is severely damaging grade at the back of the building.

- A. We recommend using a sewer camera for all storm piping below grade to identify problems with underground piping.
- B. All pitched roofs should be provided with gutters and downspouts. Provide splash blocks at grade.

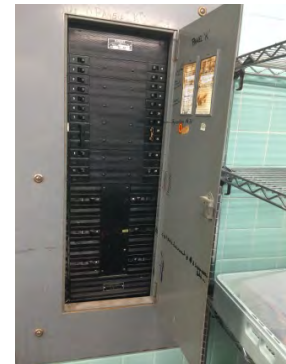
- A. A majority of the panels in the facility are old style Kinney type dated to the original construction of the facility.
- B. There are approximately 25 old style panels.
- C. Newer sections of the facility have panels in good to fair condition and do not need replacement.
- D. Staff indicated a lot of problems with breakers tripping in science labs. These are panels noted above as old style

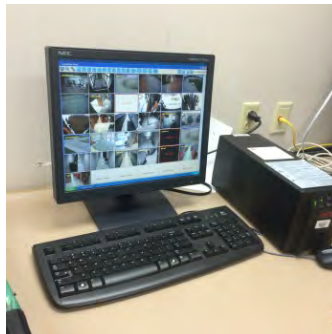
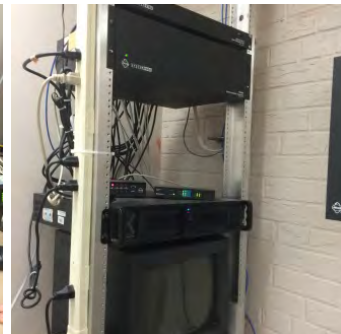
- A. A Pelco CCTV system is installed with 40 cameras located on the interior and exterior of the building.
- B. This is a non IP type system and controlled with a non-digital recorder.
- C. The facility also has an AI Phone system to allow for remote access.
